Investigations of the Material of a 50 Years old Dam in the Course of the Deepened Examination

V. Bettzieche¹ and A. Bieberstein²

Abstract

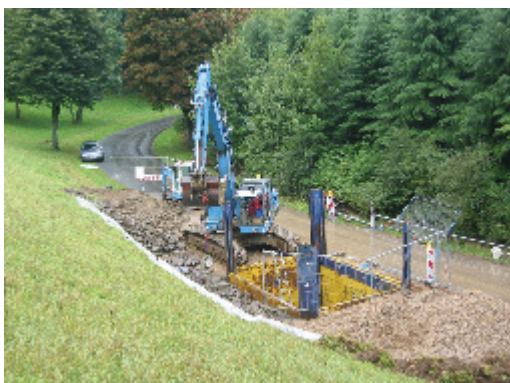
Fig. 5: Test pit on the downstream toe

The material was extracted in September 2003 in two test pits. Both explorations were in the area of the Bigge valley, one on the downstream dam toe, the other on the berm (Fig. 1

and 2). The test pits were excavated with hydraulic diggers and secured with the aid of a sliding rail support. The dimensions were around 4m x 6m; the excavation at the dam toe reached a depth of around 9m and at the berm around 7m. A total of around 46.6t of dam material was removed for further testing.

- no different material could be identified at the dam toe for the filter zone, the dam packing and the stream gravel; on the contrary, the material here is almost identical with the dam fill material at the berm.
- the natural bedrock was reached at the expected depth of around 9m.
- ground water was discovered in the area of the dam toe.
- the structure of the dam on the berm (topsoil - stony clay - coarse stone packing - dam fill) corresponds to that shown in the plans.

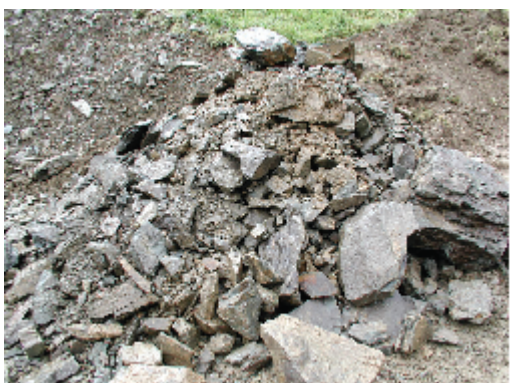
Fig. 6: Material (depth 9.0m)

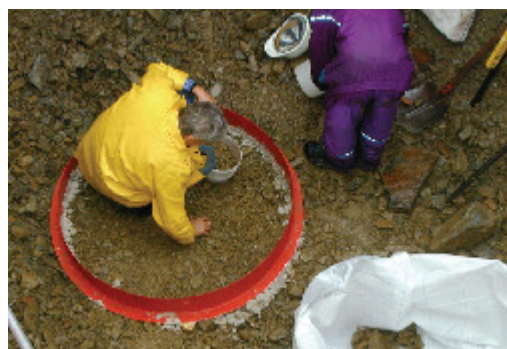
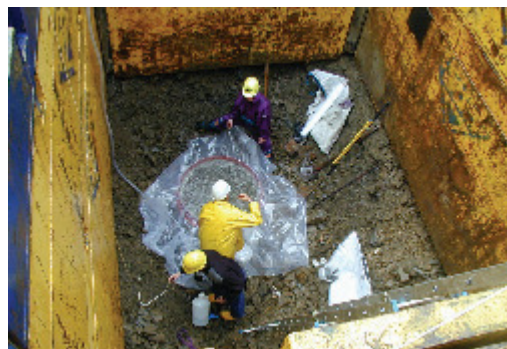
Fig. 7: Preparing the in situ tests

Fig. 8: In situ density tests with the water displacement method

γ^F	w	γ^d
Dam toe 5.5m:	20.7kN/m ³	5.5%	19.6kN/m ³
Berm 5.6m:	21.2kN/m ³	4.9%	20.2kN/m ³
Berm 7.0m:	21.7kN/m ³	5.2%	20.6kN/m ³

The careful installation of the material with the density achieved in the placing and compacting tests of $\gamma_d = 20\text{kN/m}^3$ could thus be confirmed.

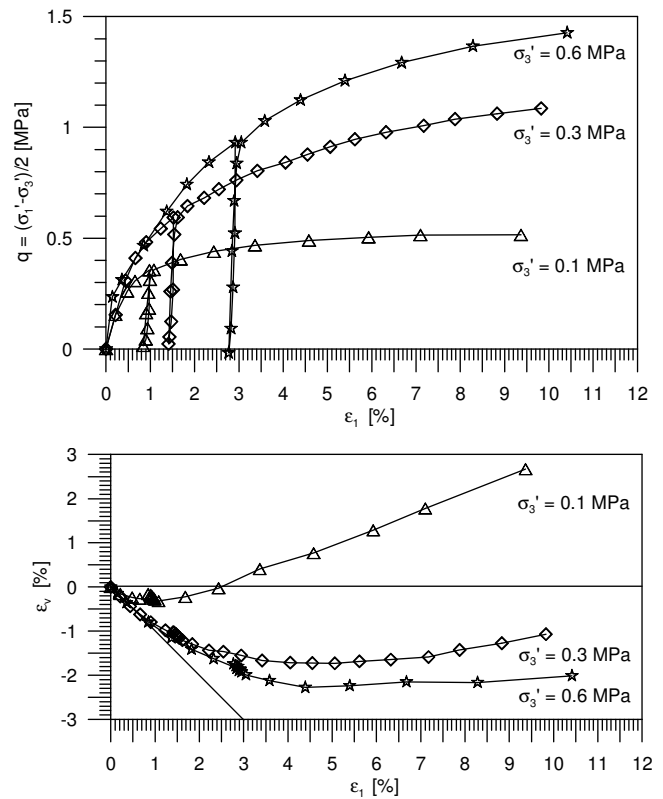
Fig. 13: Result of a series of triaxial tests on large specimens of material form the berm (tests in dry state)

Even under high dry densities of heavily precompacted rockfill (here: $\rho_d = 2.00$ t/m³) the material deforms as in one-dimensional compression ($\epsilon_v = \epsilon_1, \epsilon_3 = 0$) in the first phase of a triaxial test, and under continuous volumetric compression up to high axial strains, as is shown for the samples consisting of Bigge material from the berm (tests in dry state, cf. Fig. 13). Accordingly, no peak shear strength, not even a plateau value of strength, is observed here; instead the material consolidates under deformation and gains more and more strength (cf. Fig. 13).

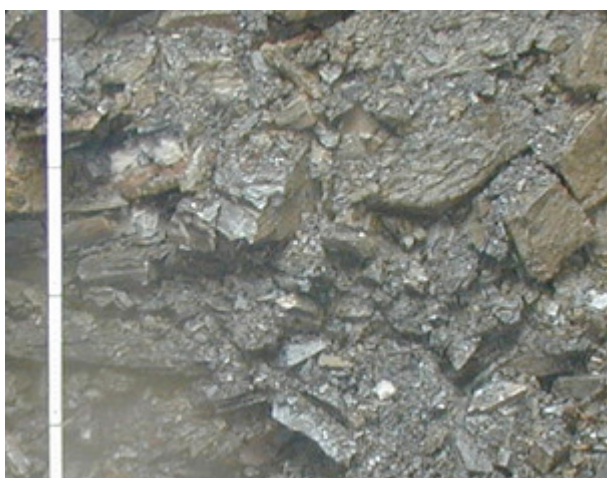
Because of the special testing conditions in the triaxial cell, the specimens show homogeneous deformation. The inner structure of the specimen is shown in Fig. 15 compared to the structure of the shell material observed in the test pit (Fig. 14).

Fig. 14: Structure of the rockfill inside the test pit of Bigge Dam

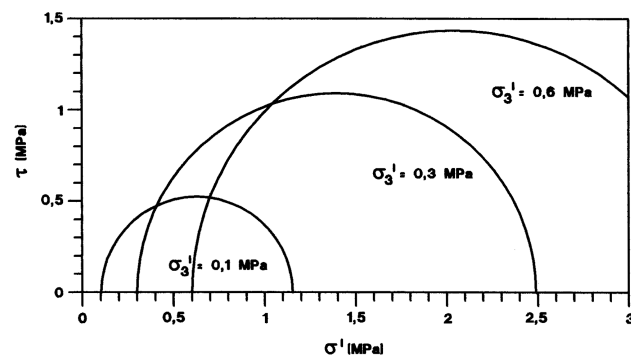
Fig. 16 shows the Mohr circles at the end of the test on the materials from the berm in a dry condition. It becomes clear that the inner angle of friction is affected by the level of stress. At a low pressure level the angle of friction is around 58° and drops to around 32° at a higher pressure level.

Fig. 16: Mohr circles for the material from the berm (dry state)

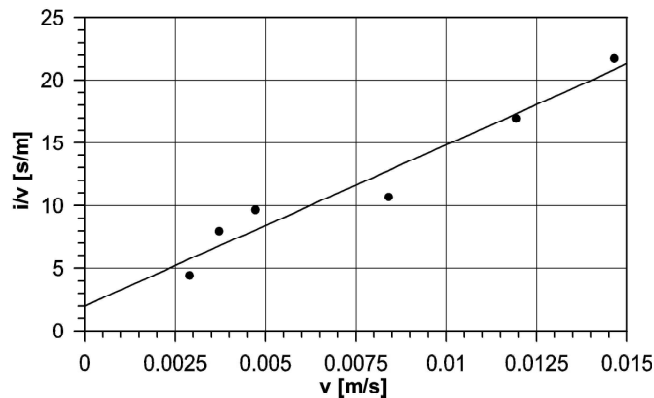
Fig. 18: Result of water permeability test (approach of Forchheimer)

A coefficient of permeability of $k = 0.5 \text{ m/s}$ was concluded for very small flow velocities. For the assessment of this value it has to be taken into account that the density achieved in the specimen might not be identical with the values on site.

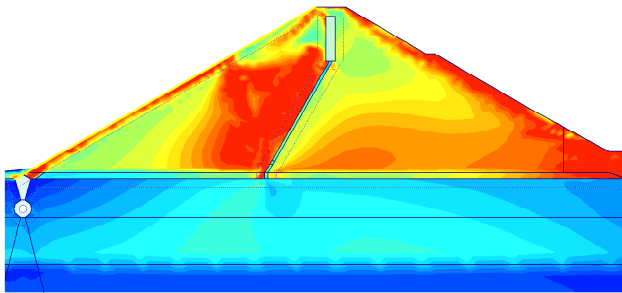
The stability analyses was carried out by finite element calculations, using the PLAXIS program system [4] for all dimensioning situations including extraordinary scenarios. Fig. 12 shows the distribution of shear stresses for the calculated case of a damaged surface seal with an assumed hole near the water level at a top water level as an example [8].

In conclusion, the stability of the Bigge Dam could be safely proven with the new examined characteristics of the material for all calculation situations.

Fig. 12: Load case hole in the surface seal with top water level: shear stresses
